SOUTHEAST PROJECT

DSL - AMRB No. 90-018 FINAL REPORT

Custer, Powder River, Rosebud, Treasure and Musselshell Counties, Montana

February 28th, 1991

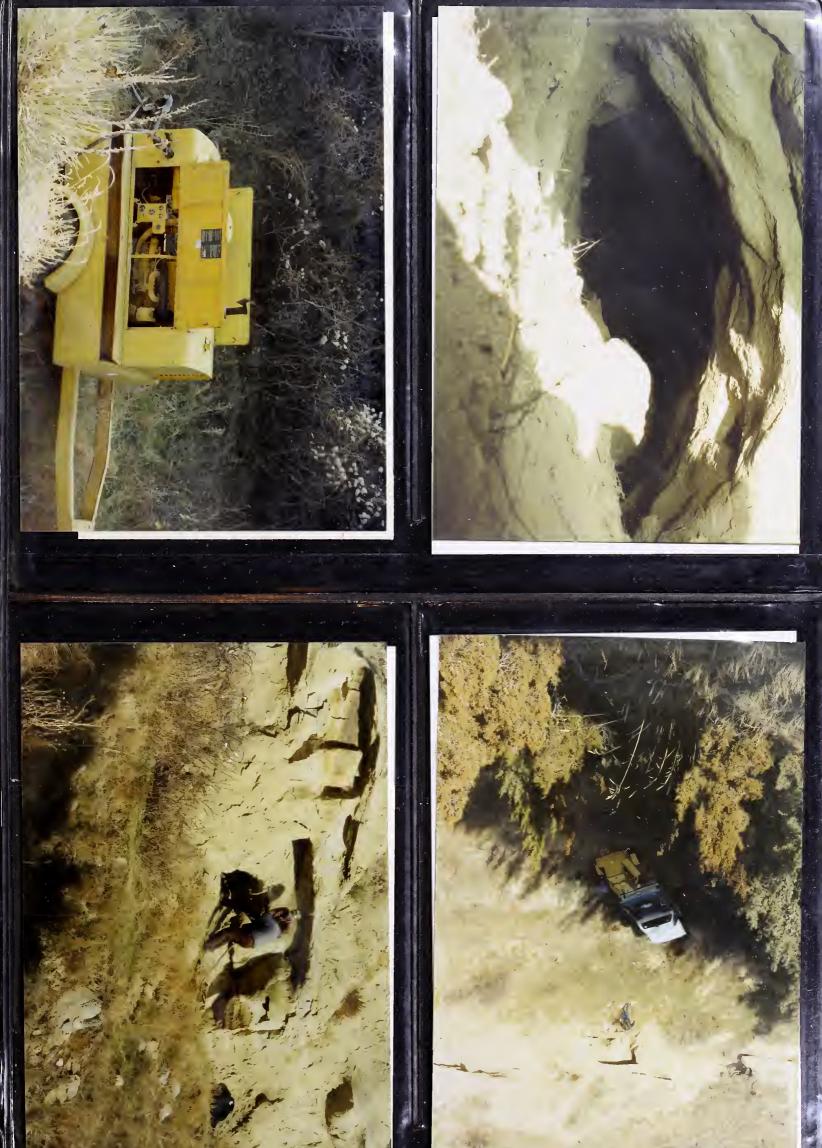
Joppa Maintenance 76N, RY3E Sec 24 December 11 1991

Initially two horizonal holes were drilled. One hole was above the opening the other hole was to the side of the opening. These holes were charged with explosives; but, the blast failed to close the opening. The loosened material was pushed down into the open adit.

Finally two vertical holes were drilled directly above the portal. These holes were charged and ignited. The thick sandstone bed above the coal seam was fractured by the blast sealing the opening and kicking out several large blocks of sandstone. A series of photographs documenting construction is enclosed. I anticipate some additional caving around the adit due to the weakness of the materials and the amount of fracturing. I suggest checking this site again in the summer.

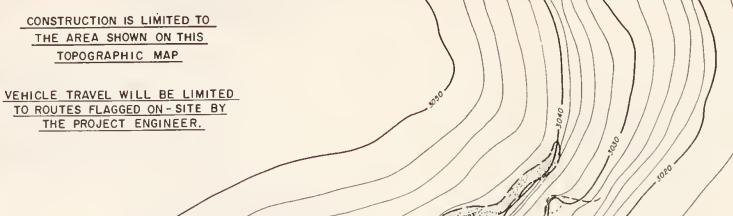
1 PICTURE 1 SHOWS ADIT 1.

FIELD ~ BACKFILLED WITH SHOVEL AND BAR CLOSE ADIT - BLASTING NOT PERMITTED BECAUSE OF THE PROXIMITY OF ASHLAND. Mile To Ashlond

• CLOSE ADIT 1 BY BACKFILLING.
